**NUMBER:** 08-016-19 REV. E

**GROUP:** 08 - Electrical

**SUBJECT:**

UAS, UAQ, UCS and UCQ Radio Enhancements

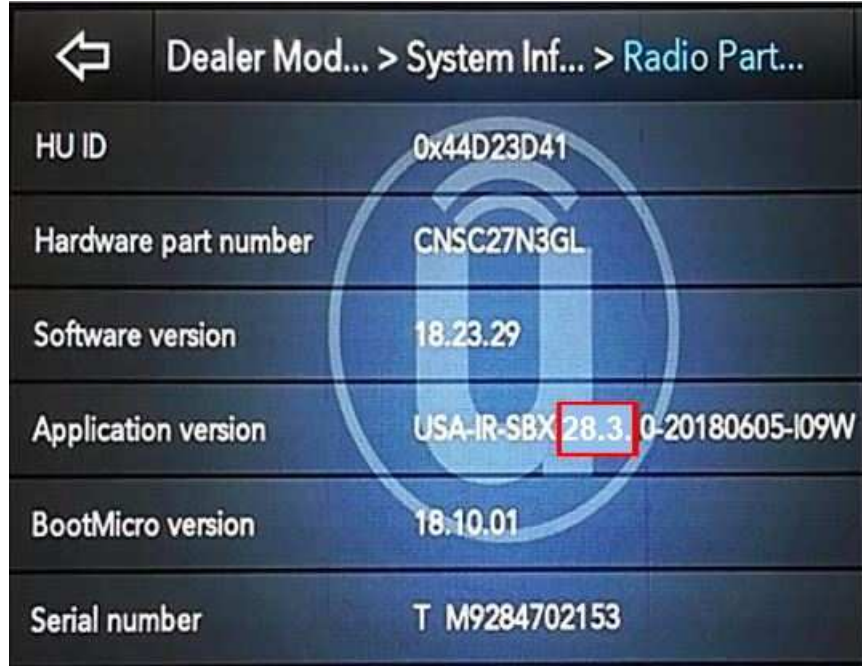
Fig. 1

1. Verify the radio software version. Radio must be in Dealer Mode to verify by following these steps:
  - Push and hold the Front Defrost, Driver Temperature Up and Temperature Down buttons simultaneously until the Dealer Mode screen appears (approximately seven seconds). Release buttons.
  - Select "Radio Part Information". The software version will be listed next to "Application Version". (Fig. 1)

Radio Software Level Screen

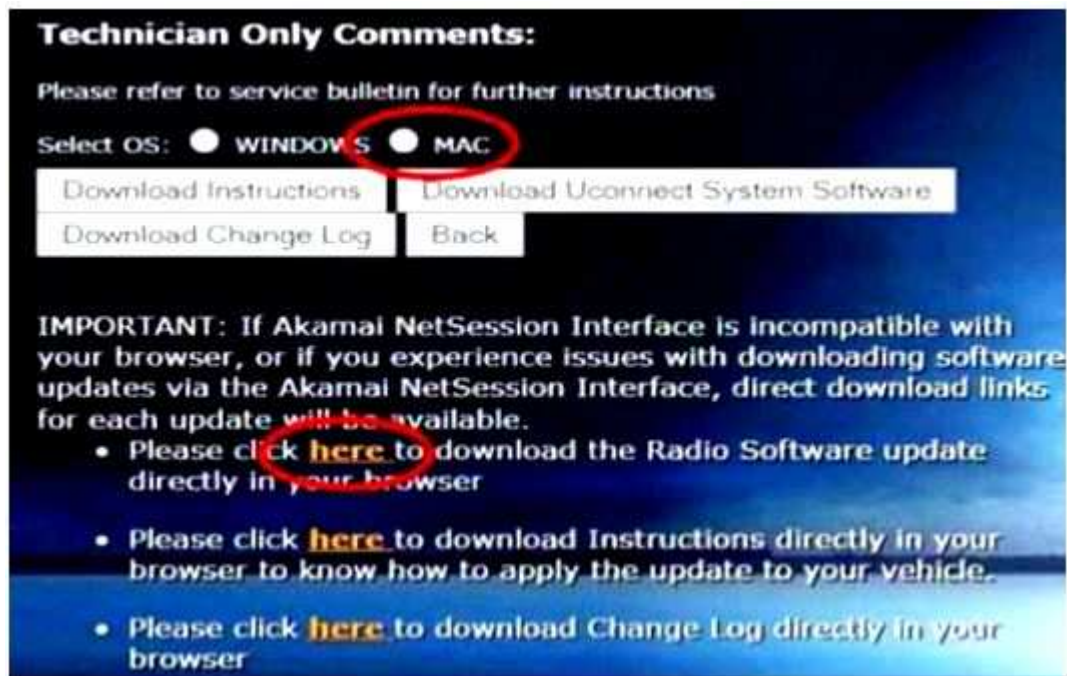
Fig. 3  
MAC Download Steps

4. Use a blank USB flash drive with at least 16GB of space. Follow the on-screen instructions to download the software files.
5. Download the software update file to your local PC's desktop. Make sure to select the "MAC" radial button for all downloads (Fig. 3) .

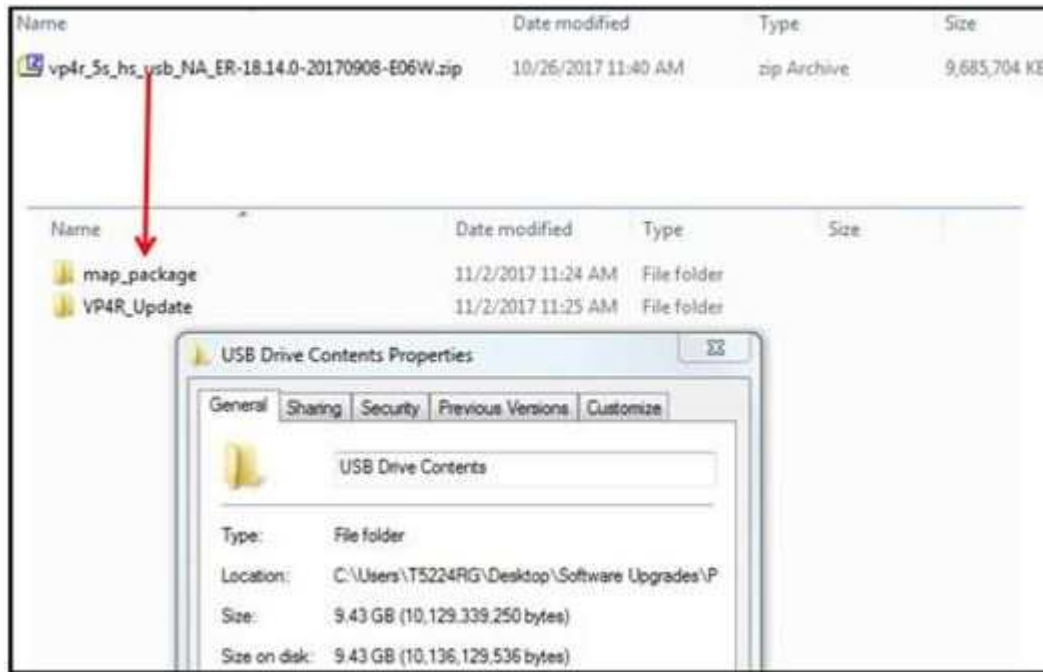
**Fig. 4**  
**Files/Folders In The USB Flash Drive**

8. Unzip all the files to the root folder of USB flash drive. Files should not be within a zip folder. Your USB files should look like (Fig. 4) when you open it, displaying multiple files/folders.

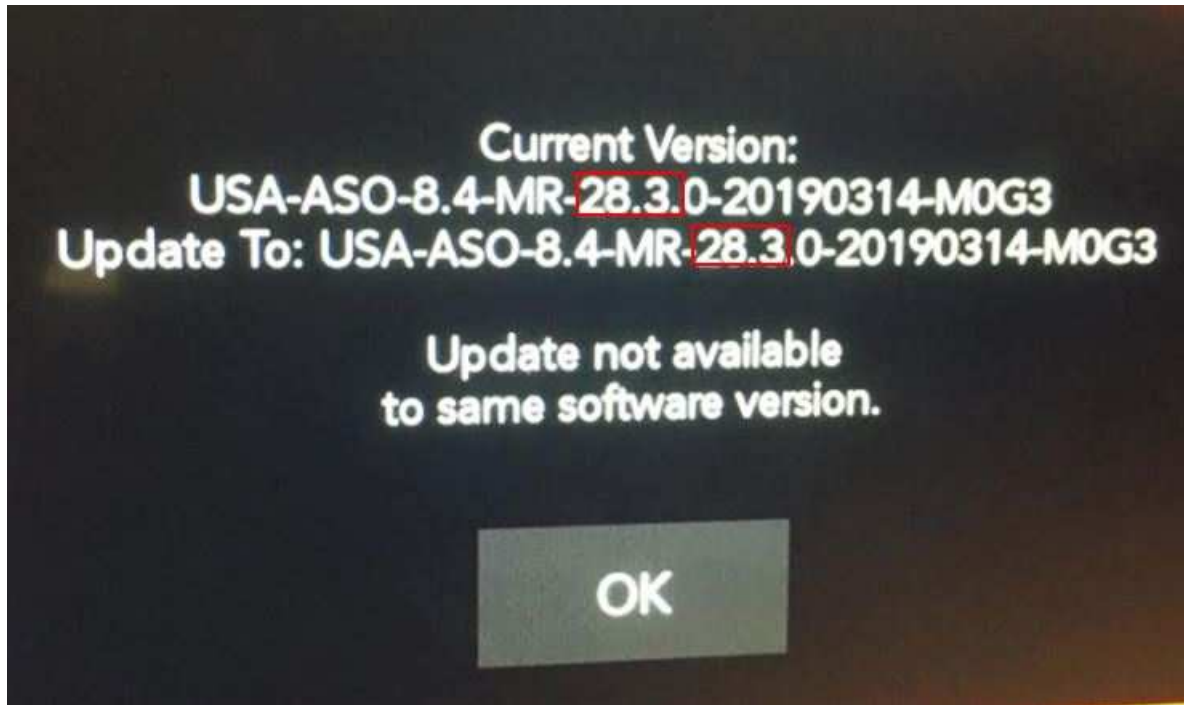
Fig. 5

Screen Displayed When Radio Software Is Up To Date

11. If the radio software is up to date, the “Current Version” and “Update To” will be the same (Fig. 5) . Press “OK” and remove the USB flash drive.

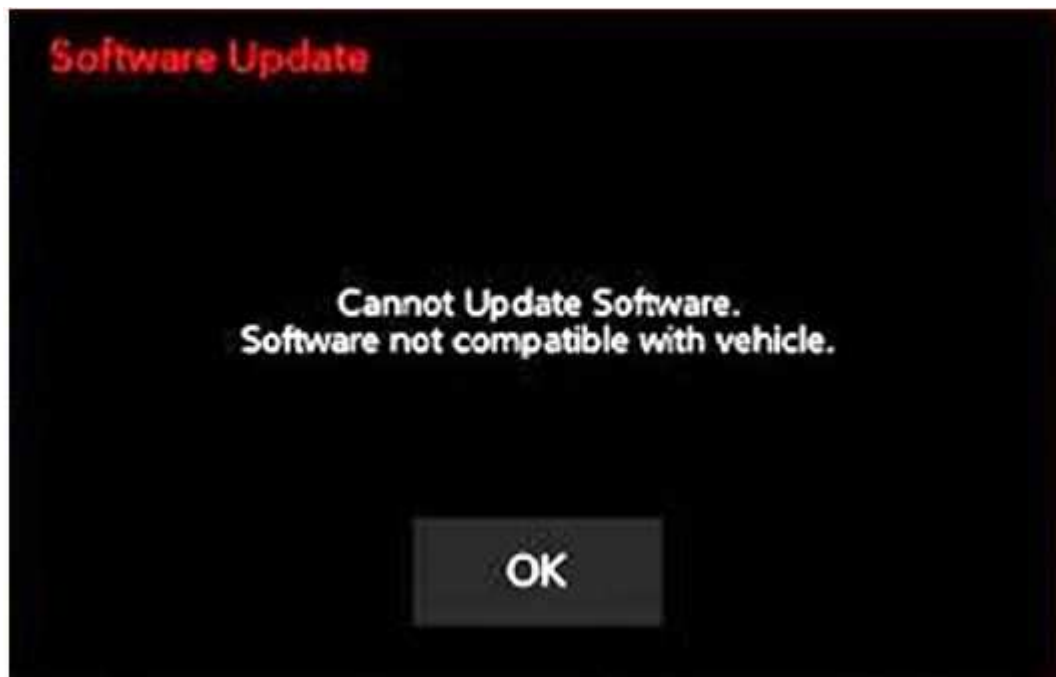
Fig. 6

12. If the screen in (Fig. 6) is displayed, the USB flash drive was not set up correctly. Use a top name brand USB and create a new flash drive and start the update again.

Software Not Compatible

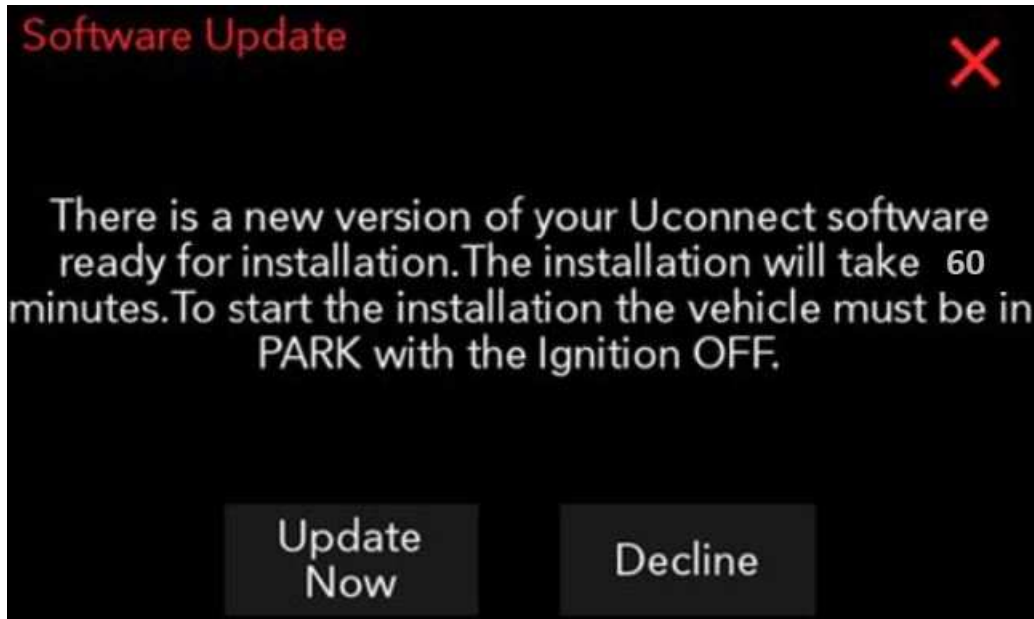
Fig. 7

Software Update Is Available

13. Once the system has verified there is an available update, touch the “Update Now” button. Make sure the vehicle is in park, **do NOT turn off the ignition at this point**, (Fig. 7) .

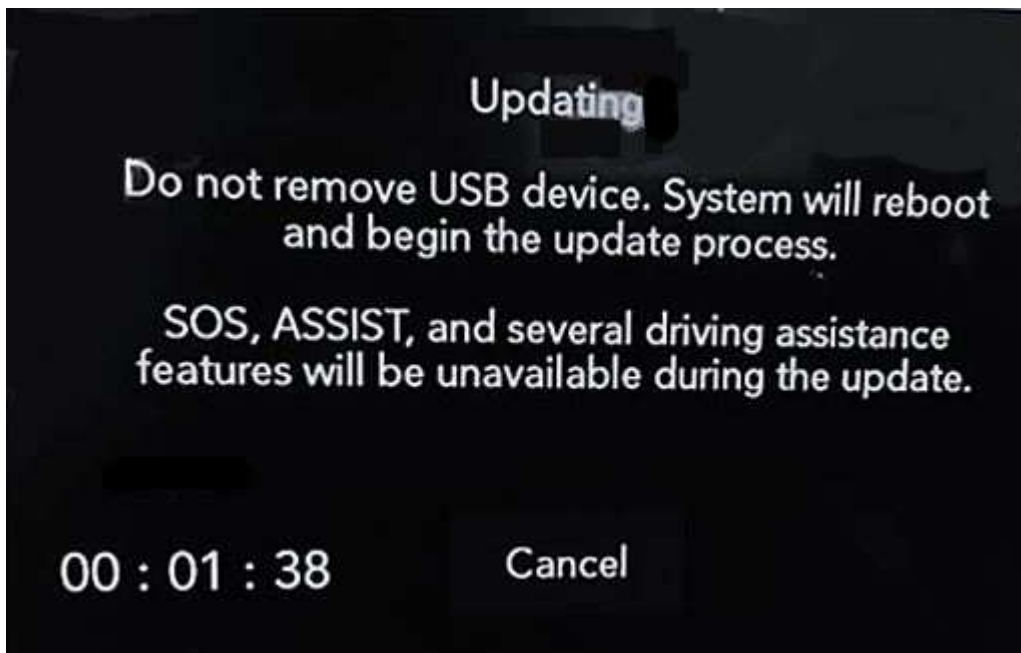
Fig. 8

Radio Update Process Begins

**NOTE:** Do not turn off the ignition until the two minute timer has expired, as seen in (Fig. 8) .

14. The ignition must be turned to the off position **before** the two minute timer has expired, or the update may be canceled, (Fig. 8) .

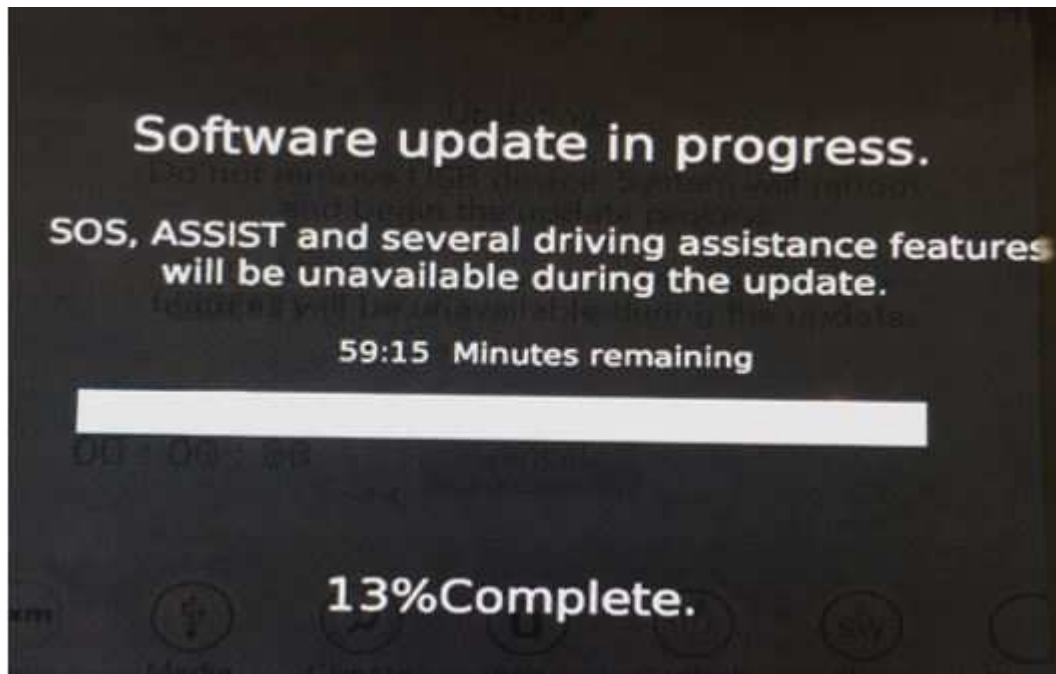
Fig. 9  
Software Update In Progress

15. The radio will reboot and the update will begin. The update should only take 20 minutes, the timer on the screen may display the incorrect time remaining, (Fig. 9) .

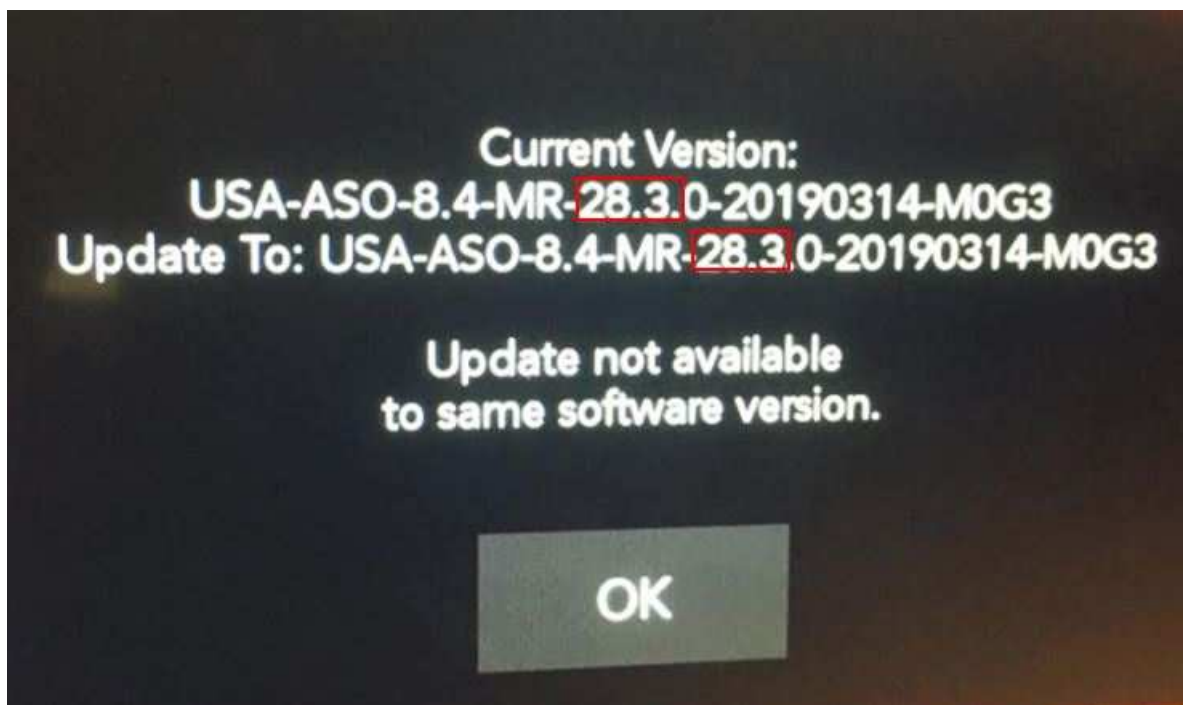
Fig. 10  
Radio Software Has Been Updated

16. After the update has completed, the radio will shut down. With the USB flash drive still inserted in the USB port, turn the ignition back to the run position. If the radio has been updated correctly, the screen in (Fig. 10) will be displayed. Press "OK" and remove the USB flash drive.
