**NUMBER:** 08-133-21

**GROUP:** 08 - Electrical

**DATE:** August 6, 2021

UAQ and UCQ Radio Enhancements

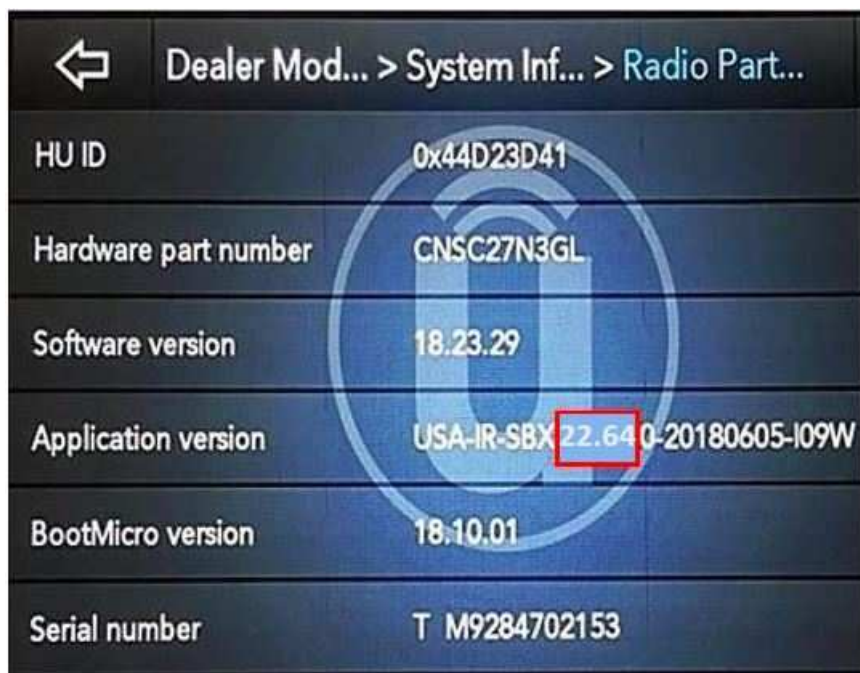
Fig. 1

Radio Software Level Screen

1. Verify the radio software version. Radio must be in Dealer Mode to verify by following these steps:
  - a. Press and hold both lower corners of the display screen, until the Dealer Mode screen appears (approximately seven seconds). Release screen.
  - b. Select "Radio Part Information". The software version will be listed next to "Application Version" (Fig. 1) .

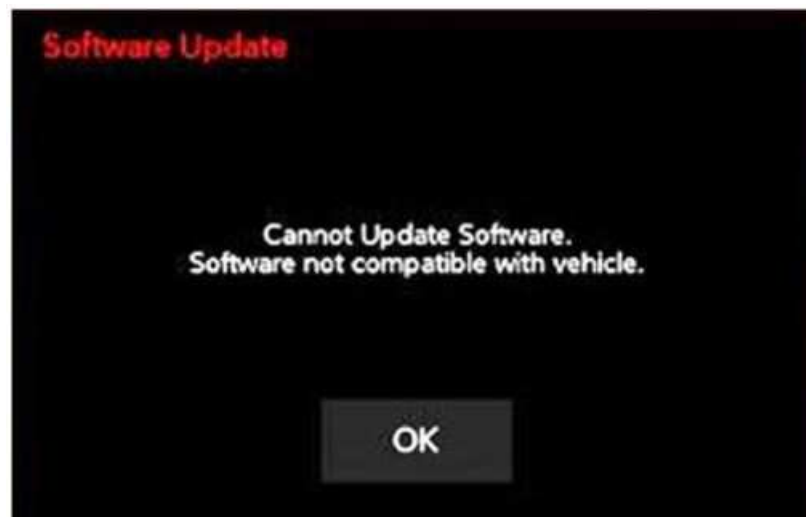
Fig. 5  
Software Not Compatible Screen

11. If the screen in (Fig. 5) is displayed, the USB flash drive was not set up correctly. Use a top name brand USB flash drive, like Kingston, create a new USB flash drive and start the update again.

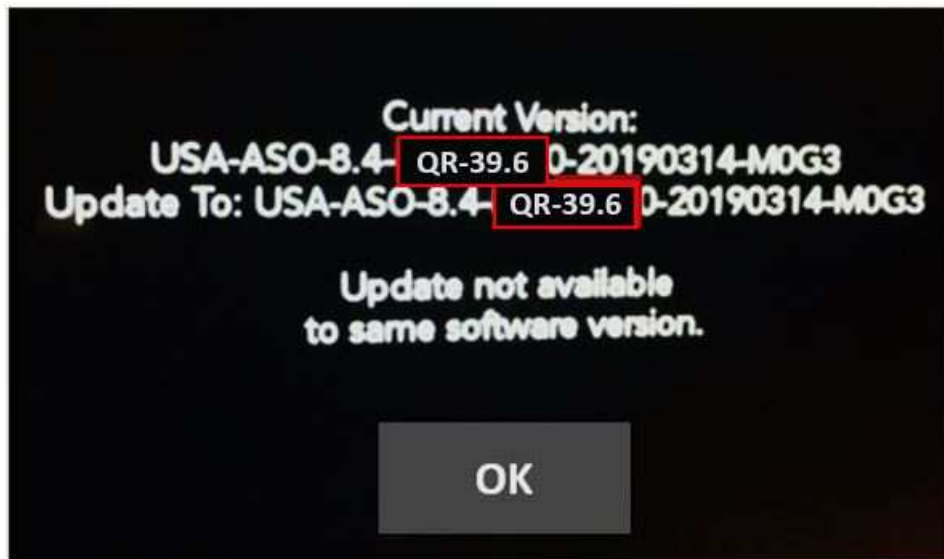
Fig. 6

12. If the radio software is already up to date, the screen in (Fig. 6) will be displayed. Press “OK” and remove the USB flash drive.

Screen Displayed When Radio Software Level Is Up To Date

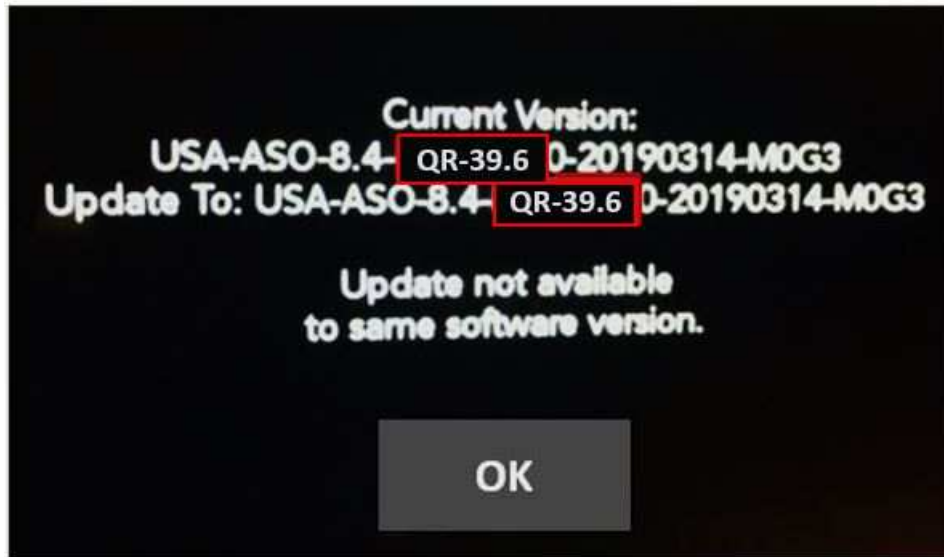
Fig. 10  
Radio Software Has Been Updated

16. After the update has completed, the radio will shut down. With the USB flash drive still inserted in the USB port, cycle the ignition back to the run position. If the radio software was updated correctly the “Current Version:” and the “Update To:” software levels in (Fig. 10) will display the identical software level. Press “OK” and remove the USB flash drive.
