**Technical Service Bulletin (TSB)**  
**UAQ and UCQ Radio Enhancements**

| <b>REFERENCE:</b> | <b>TSB:</b> 08-003-22<br>REV. A<br><b>GROUP</b> 08 -<br>Electrical | <b>Date:</b> | December 16,<br>2022 | <b>REVISION:</b> | <b>08-003-22 and<br/>08-133-21</b> |

| <b>CAUSE:</b> | <b>Radio software</b> |

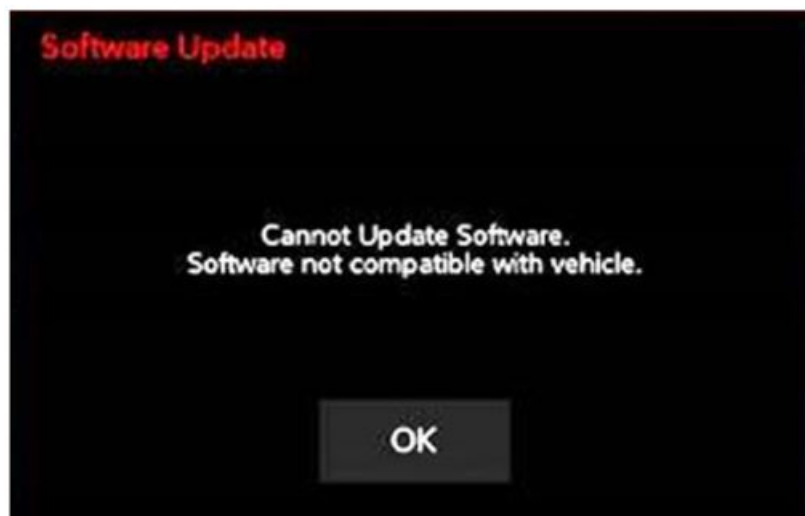
Fig. 4  
Software Not Compatible Screen

10. If the screen in (Fig. 4) is displayed, the USB flash drive was not set up correctly. Use a top name brand USB flash drive, like Kingston, create a new USB flash drive and start the update again.

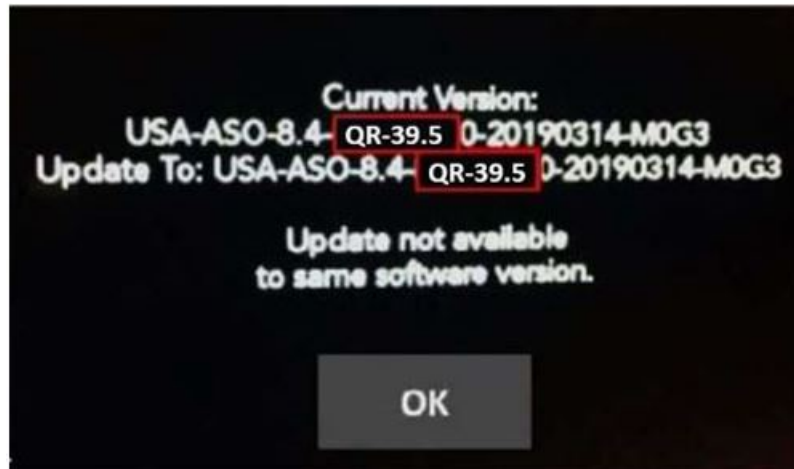
Fig. 5

Screen Displayed When Radio Software Level Is Up To Date

11. If the radio software is already up to date, the screen in (Fig. 5) will be displayed. Press “OK” and remove the USB flash drive.

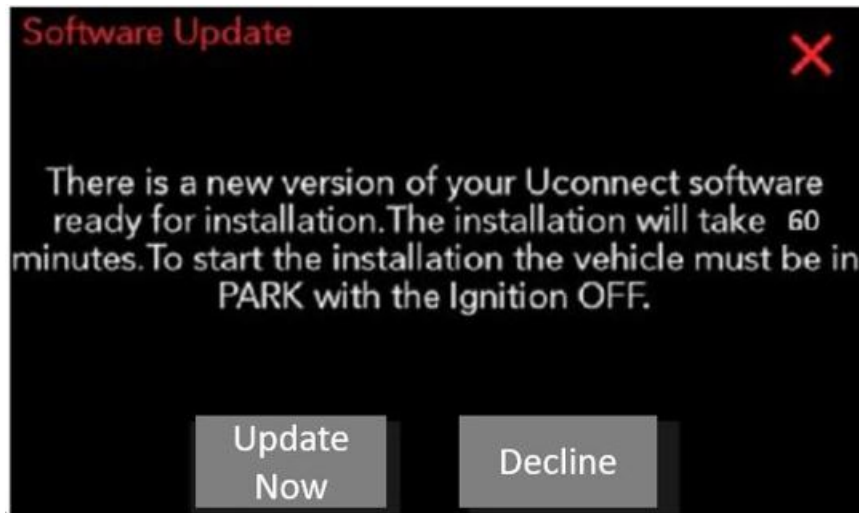
Fig. 6

Software Update Is Available

12. Once the system has verified there is an available update, press the “Update Now” button. Make sure the vehicle is in park, **DO NOT** turn off the ignition (Fig. 6) .

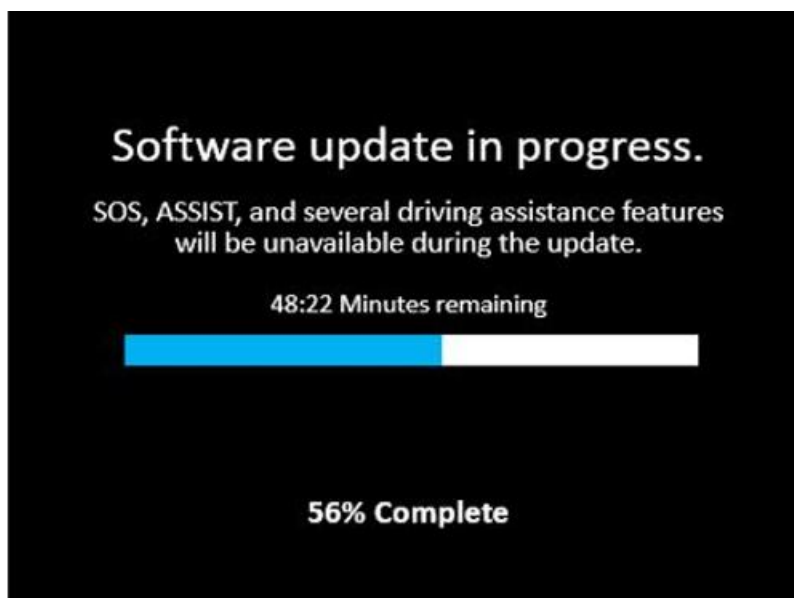
Fig. 8  
Software Update In Progress

14. The radio will reboot and the update will begin. The update should only take 25 minutes, the timer on the screen may display the incorrect time remaining, (Fig. 8) .

**NOTE: The completion indicator may not reach 100%, even though the software update has been completed. Once the software update has finished, the radio and display screen will turn off.**

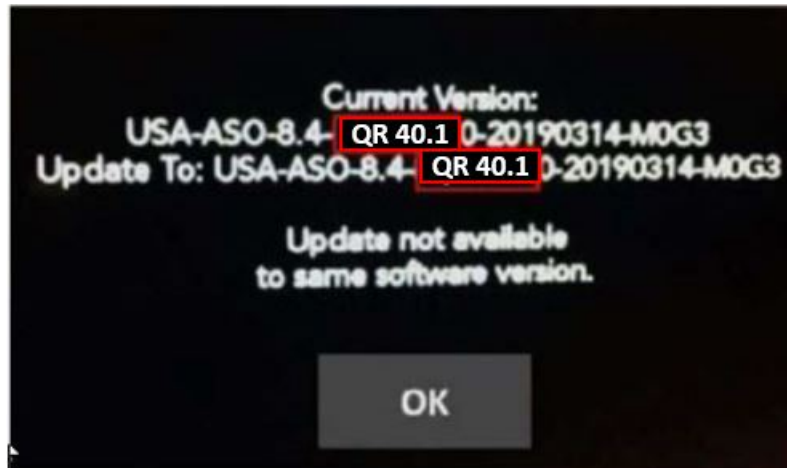
Fig. 9

**Radio Software Has Been Updated**

15. After the update has completed, the radio will shut down. With the USB flash drive still inserted in the USB port, cycle the ignition back to the run position. If the radio software was updated correctly the “Current Version:” and the “Update To:” software levels in (Fig. 9) will display the identical software level. Press “OK” and remove the USB flash drive.
